Pre-Purchase Standard Property & Timber Pest Report

01st Feb, 2021

Report number:	
Inspection Date:	26th Jan, 2021
Property Address	REDACTED

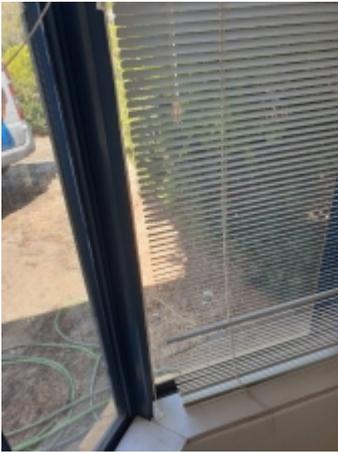
Window treatment not secured to the wall, this could present choking or strangulation hazards and should be secured back to the wall

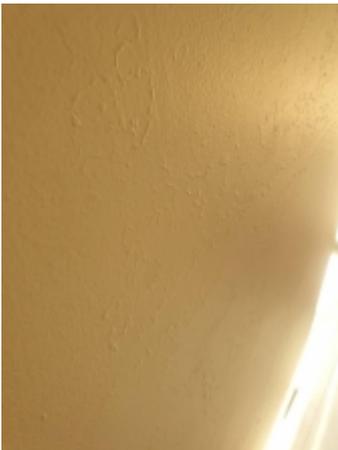
Leak to shower has allowed Brick work to absorb water and this has begun to show by the paint peeling on the opposite side. Moisture tests are performed to determine levels of moisture

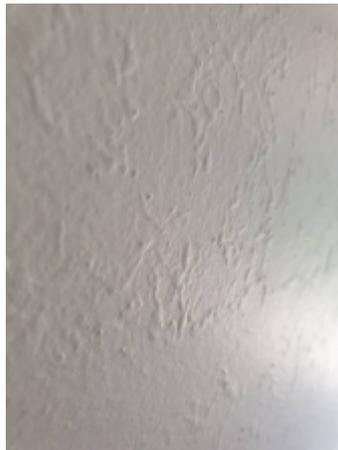
Leak to shower has allowed Brick work to absorb water and this has begun to show by the paint peeling on the opposite side. Moisture tests are performed to determine levels of moisture

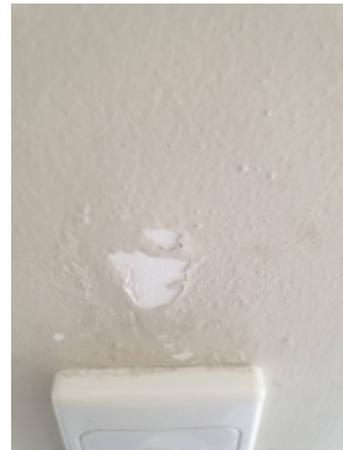
Leak to shower has allowed Brick work to absorb water and this has begun to show by the paint peeling on the opposite side. Moisture tests are performed to determine levels of moisture

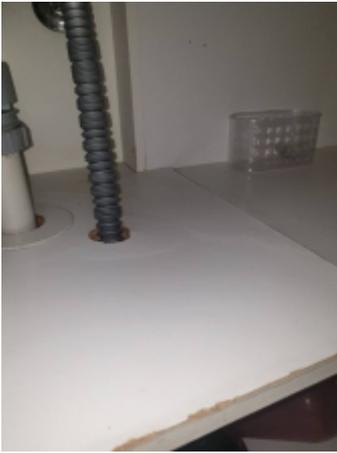
Water damage to million style cabinet, the shelf offers support to the corner cabinet and as a result the stone benchtops, if this shelf fails, cracking could occur to the bench top

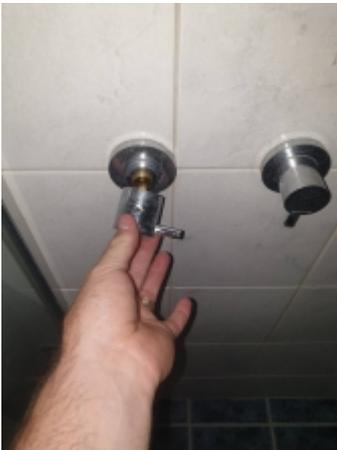
Loose fitting, grub screw to be inserted and tap tightened

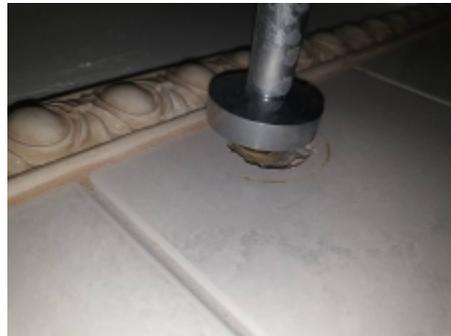
Incorrect fitting to shower rose, conducive to shower leaks and require plumber to reinstall

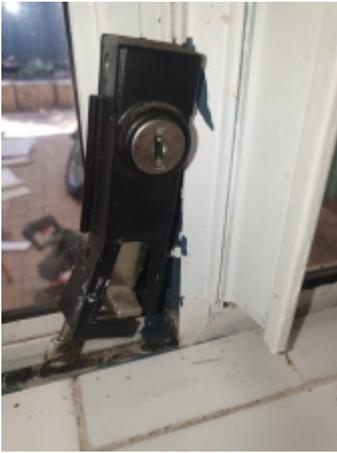
Window unable to open due to snapped and jammed locking mechanism.

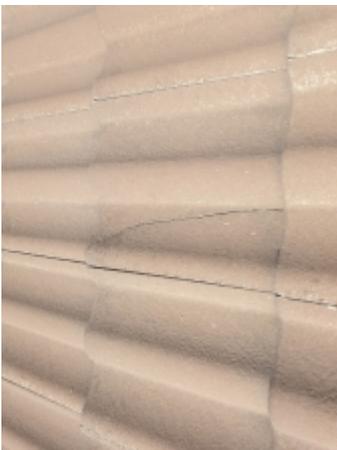
Some cracking to ridges and tiles, this can cause water to get into the roof space and leaks to become evident, suggest repoint and seal.

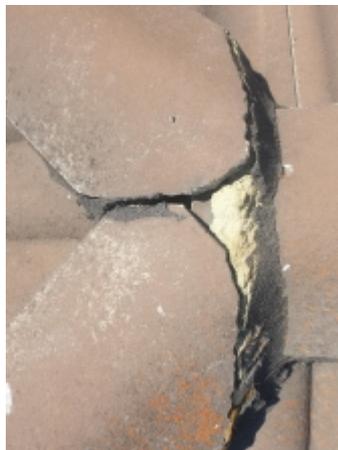
Some cracking to ridges and tiles, this can cause water to get into the roof space and leaks to become evident, suggest repoint and seal.

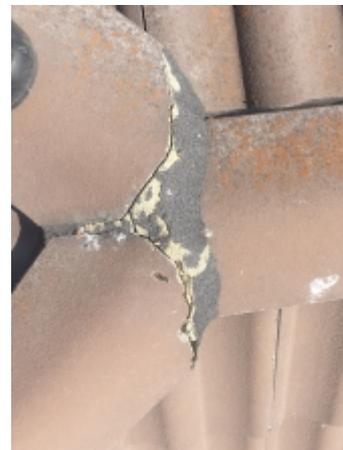
Some cracking to ridges and tiles, this can cause water to get into the roof space and leaks to become evident, suggest repoint and seal.

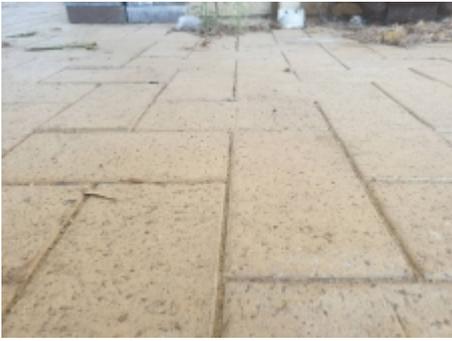
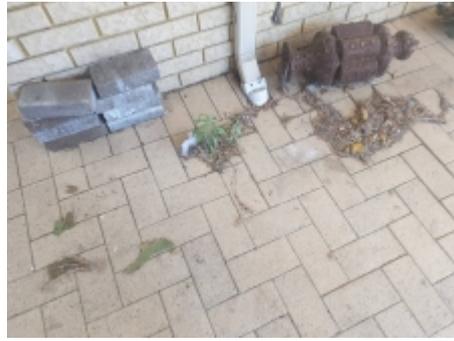
Water from downpipe is not adequately directing water into the soak well, as such, is undermining the sub straight for the pavers and the pavers are starting to sink

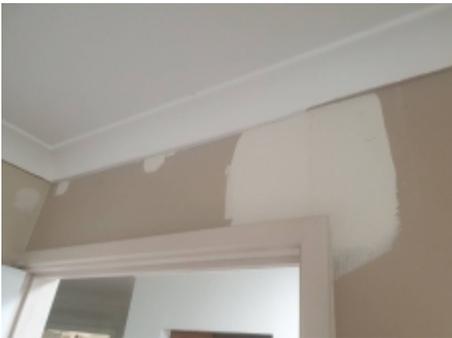
Poor workmanship, gyprock should cover the entire wall and not finish flush with brickwork, cracking is otherwise possible as the expansion coefficients differ, also sanding is require to finishing top coat and painting

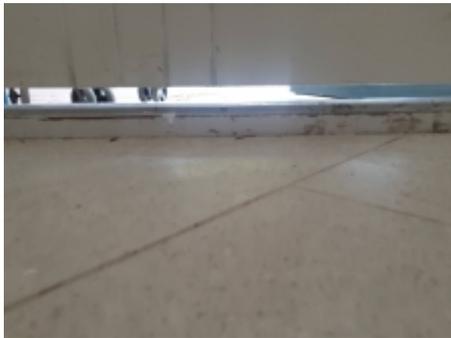
Missing door threshold seal, suggest to install a new one, this can assist in wind coming through as well as rain and pests

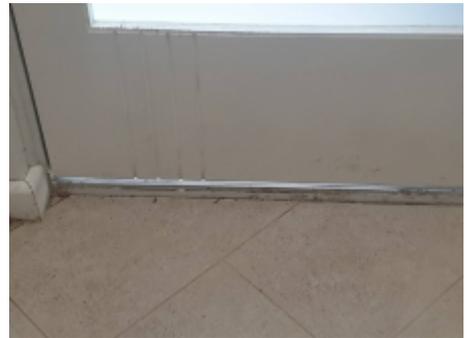
Missing door threshold seal, suggest to install a new one, this can assist in wind coming through as well as rain and pests

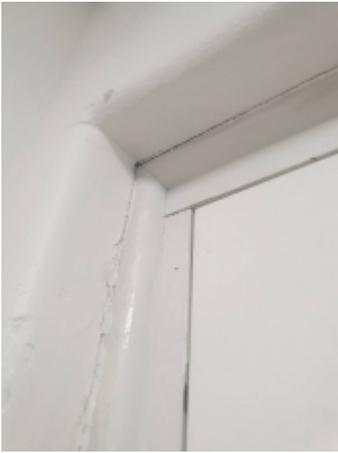
Quad separation from brickwork, this can occur over time from closing the door, it's a minor and unavoidable

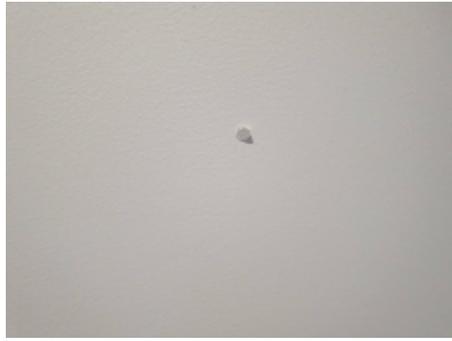
Nail popping to ceiling, this can happen when ceiling come loose from the joists, or have had impact from the roof space, resecuring the ceiling back to the joists, flushing and painting will remedy this

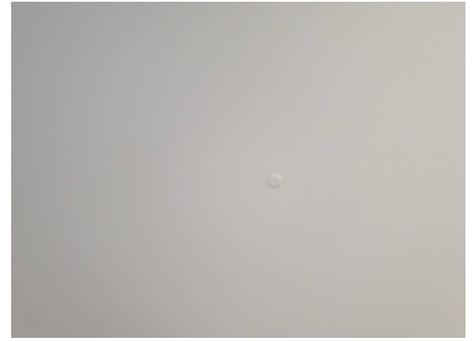
Nail popping to ceiling, this can happen when ceiling come loose from the joists, or have had impact from the roof space, resecuring the ceiling back to the joists, flushing and painting will remedy this

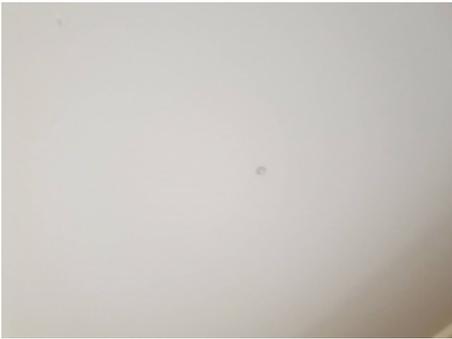
Nail popping to ceiling, this can happen when ceiling come loose from the joists, or have had impact from the roof space, resecuring the ceiling back to the joists, flushing and painting will remedy this

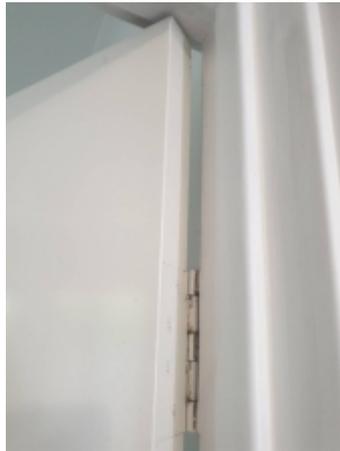
All WC doors require lift off hinges, this is a safety requirement part of the NCC

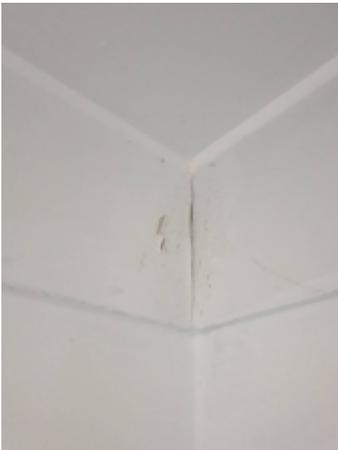
Paint peeling to ensuite cornice, typically caused from excess exposure to moisture, treatment flush and paint will avoid further paint delamination and swelling

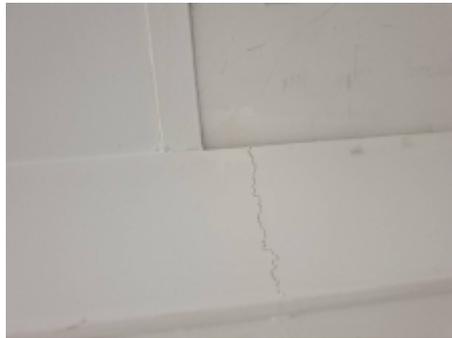
Cornice crack to manhole entrance, most likely from access to the roof space over time.

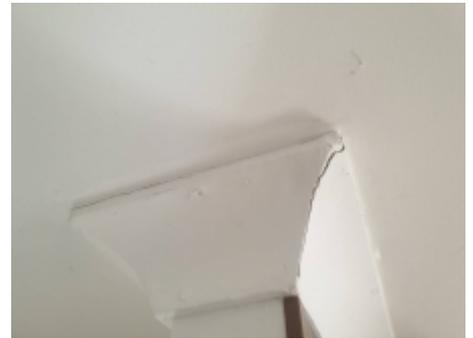
Cornice crack as well as separation, settling cracks are common and sometimes unavoidable

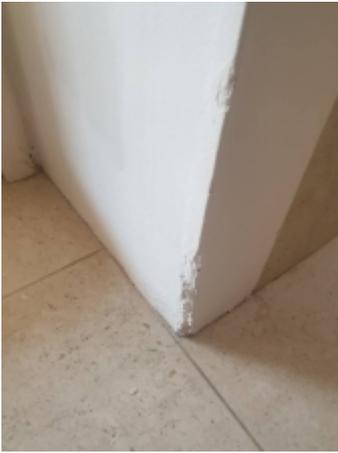
Skirting missing, gyprock wall damaged due to impact, installing skirting to this location will aid in further impact damage to the wall

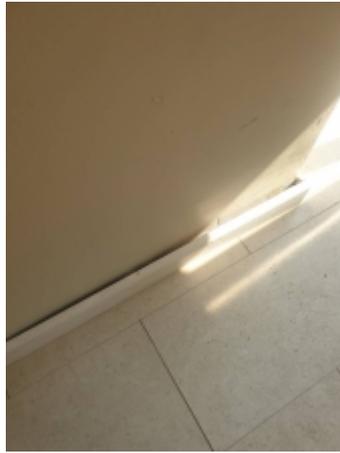
Skirting has come loose from wall, nail and glue back to wall and seal the skirting.

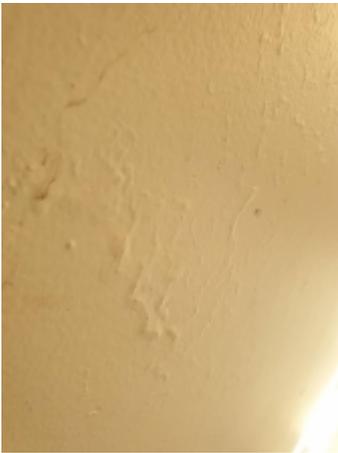
Leak to shower has allowed brick work to absorb water and this has begun to show by the paint peeling on the opposite side, moisture tests are carried out and have returned a high moisture content, fixing a leaking shower and repairing the wall will prevent further bubbling

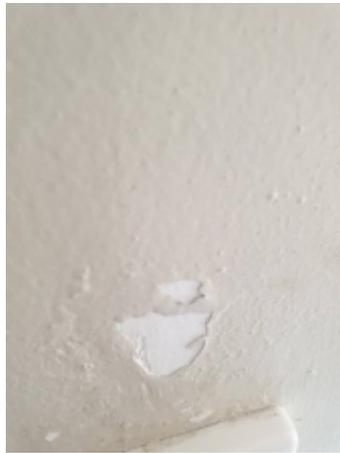
Leak to shower has allowed brick work to absorb water and this has begun to show by the paint peeling on the opposite side, moisture tests are carried out and have returned a high moisture content, fixing a leaking shower and repairing the wall will prevent further bubbling

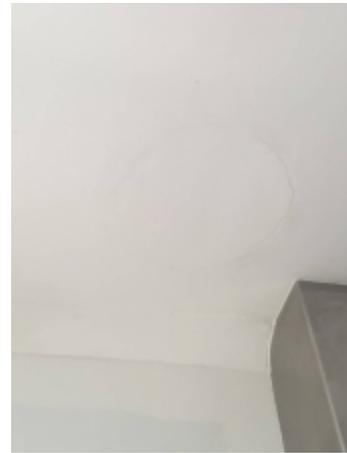
Previously repaired extraction fan hole, evidence of cracking to joins, recommend back blocking and re flushing

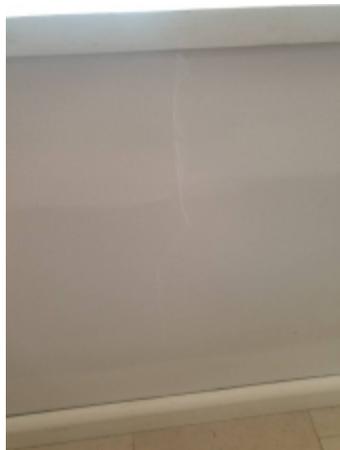
Previously repaired wall crack, crack caused from roots below footings, roots cleared and no longer risk

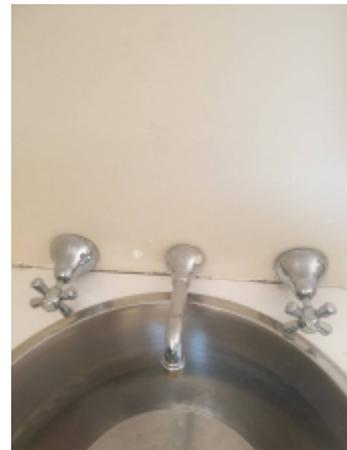
Taps too low to bench, sealing bench top also required

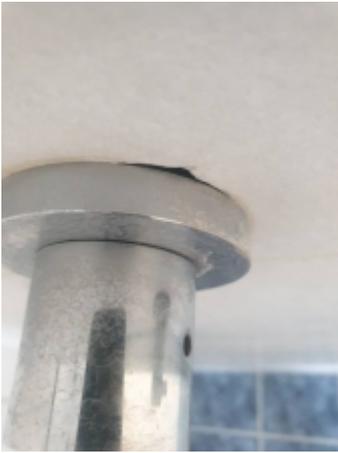
Incorrect tap flange installed, this can be a conducive factor to shower leaking

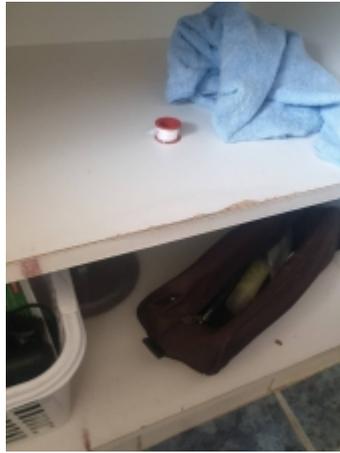
Moisture damage to cabinets

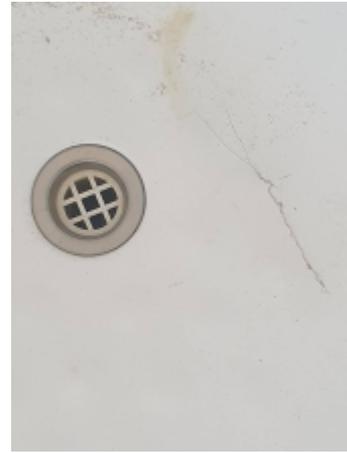
Cracked bath tub

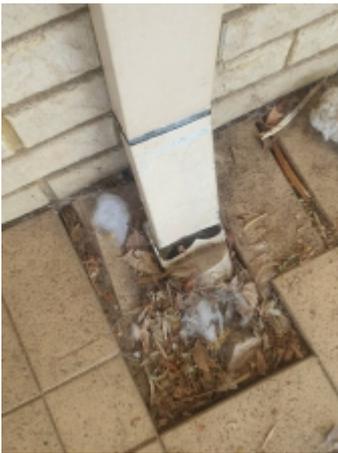
Damaged down pipe and it is not correctly connected to soak well

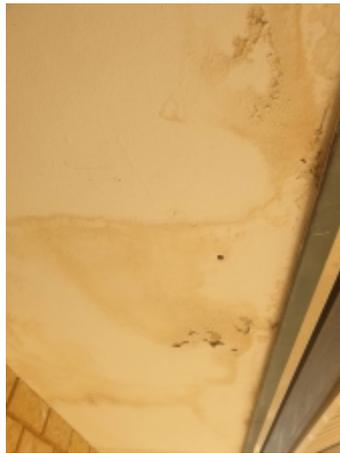
Evidence of water damage to hardi flex eaves, this can be caused by water from overflowing gutters or ingress from tiles, as there is no insulation to external eaves risks of moisture showing in the hardi flex is greater

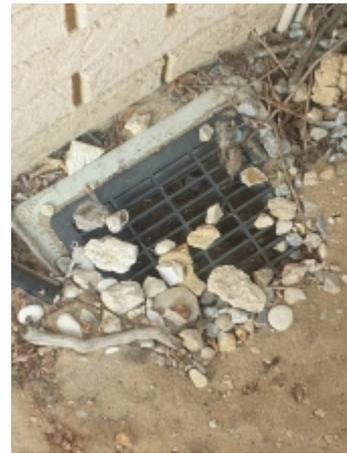
Blocked drains, these should be cleared out.

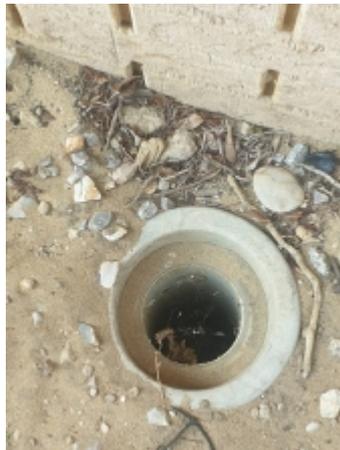
Missing covers

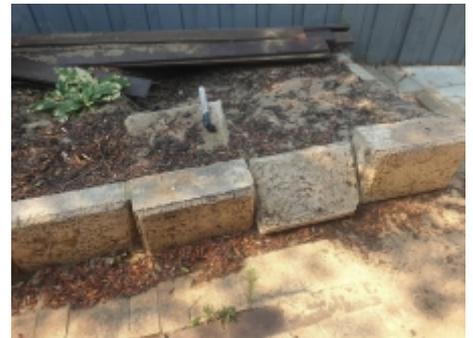
Leaning and loose limestone blocks for garden retaining wall

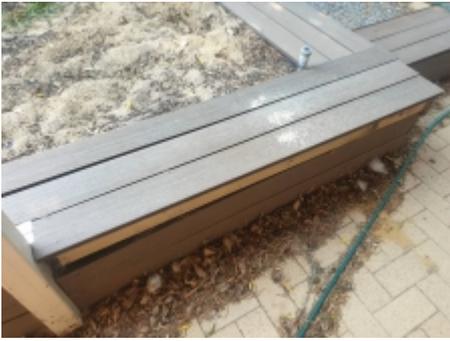
Missing deck panels, (acrylic deck)

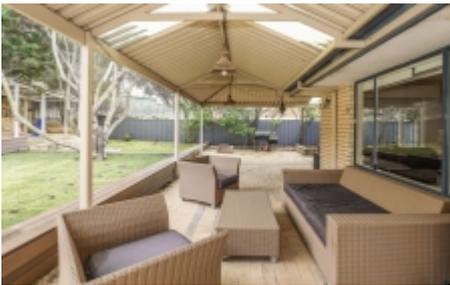
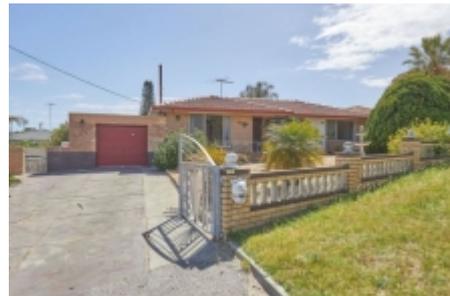
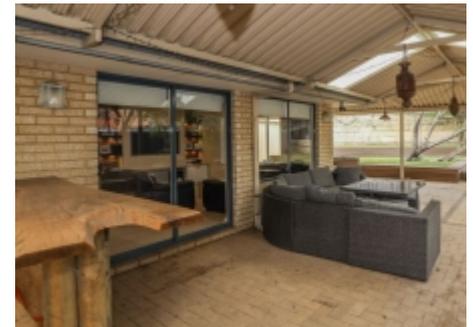
E11 Bridging or breaching of termite barriers and inspection zones	The following evidence was found
--	----------------------------------
