Pre-Purchase Standard Property & Timber Pest Report

01st Feb, 2021

Report number:	
Inspection Date:	26th Jan, 2021
Property Address	REDACTED

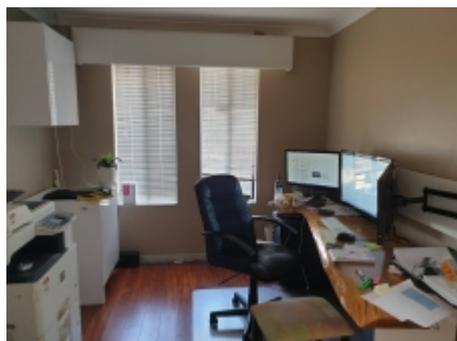
Obstruction Photos

Furniture can sometimes hide defects, this statement is true and typical to any and all furniture

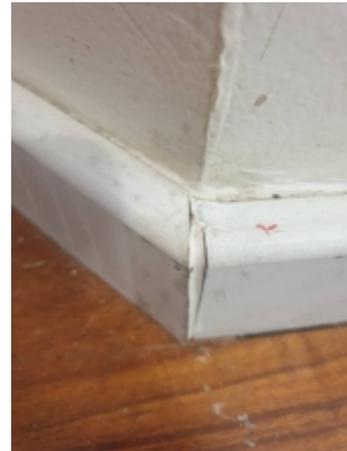
Poor workmanship to skirting, flooring should go under the skirting as well as joins being done as a 22.5 degree mitre cut and sealed adequately

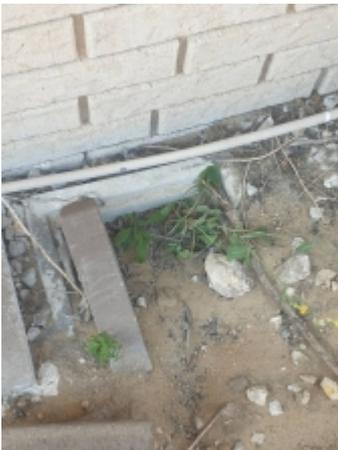
Blocked drains, these should be cleared out.

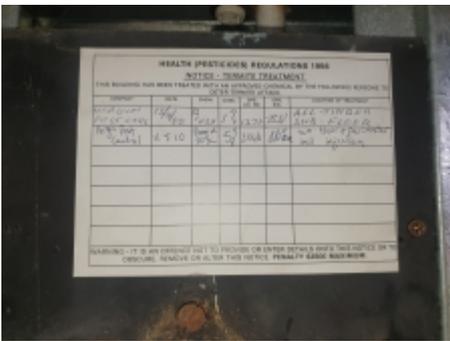
Previous Treatment Photos

E1 Active (live) termites	No evidence was found
E2 Subterranean termite management proposal	A Proposal is recommended
Additional Comments	
E3 Termite workings and/or damage	No evidence was found
E4 Previous termite management program	The following evidence was found:
Evidence of previous program:	Treatment sticker in meter box
